# Pulsar News

Published by Aero Designs Inc.

Issue No.37

MAY, 1996

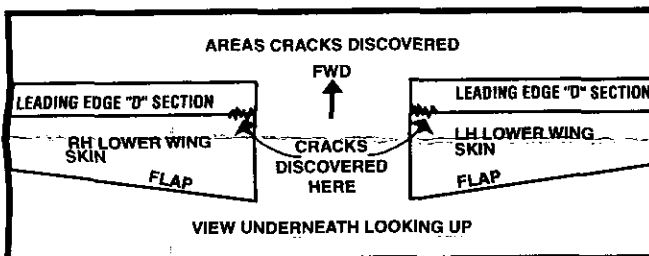
Recently, we were informed by one of our Pulsar 582 customers of a problem he encountered during the structural high "G" flight testing of his airplane.

After pulling at least 4 "G" on a proof load test flight, he noticed cracks developing in both left and right lower wing skin seam lines. The cracks were forming on the bottom surfaces of both wings in the bonded joint where the wrap around leading edge skin and the aft lower skin butt together over the inboard section of the main spar (see illustration below for orientation).

The bond of the aft skin to the main spar was found to be cracking and pulling away slightly from the spar beginning at the number one inboard rib.

First, it must be noted that this is not a critical safety of flight issue. The aft wing skin will not pull completely away from the spar. The crack, over time, might grow to the next rib location, but it will stop there. Only over a long period of time and after many high "G" exposures could the crack in the bond grow any further.

For those of you who have finished, painted and are currently flying your Pulsars, begin including this area of the seam lines of the lower skins at the inboard sections of both wings as part of your normal preflight check. If any small cracks begin to develop in these areas, they will be immediately evident and visible. If you find cracks and they appear to be growing over time, they should be repaired during the next annual maintenance period as detailed in the procedure below.

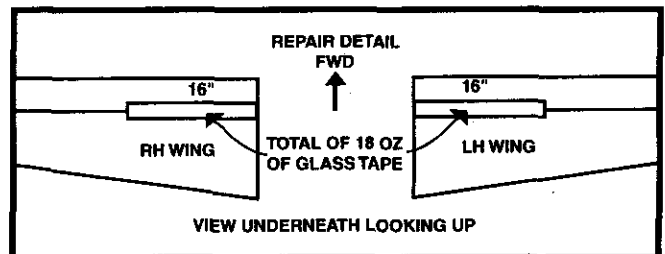
The area of this joint to be reinforced is from the absolute inboard edge of the seam out to a distance of 16 inches as shown above.

## RECOMMENDED REPAIR PROCEDURE FOR LOWER WING SKIN SEAM JOINTS

1. On both left and right lower wing surfaces, locate the seam joint of the inboard leading edge skin (the "D" section) and the aft skin panel where they butt together and are bonded over the main spar (see illustration below).

2. The idea is to add a total of 18 ounces of 2 inch glass tape over the 16" length of the seam. This can be accomplished by applying two 9 ounce layers of 2 inch glass tape or six 3 ounce layers of 2 inch glass tape over the seam. Using six 3 ounce layers will probably be easier since three layers can be "feathered" on the edges and can be smoothed in better with the wing skin surface.

3. For aircraft that are already painted, it is important that all paint and filler be removed from the area over the seam to be reinforced. The area over and around the seam should be sanded and cleaned down to the original fiberglass or plywood surface. This will insure

4. After curing, the glass tape reinforcement over the seam joint can be filled, sanded and repainted.
